Manhole Inspection Summary

Manhole # S11EE1008MH

Insp Date: **6/21/07 1:02 PM**

Location Address: **3056 EAST WABASH RD** Cross Street: **COLD SPRINGS LN**

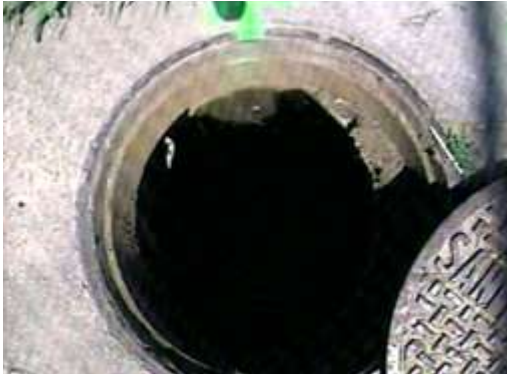
Top View

Frame Offset: **3** (in.) Condition: ☒ Sound ☐ Cracked ☐ Leaks

FRAME OFFSET

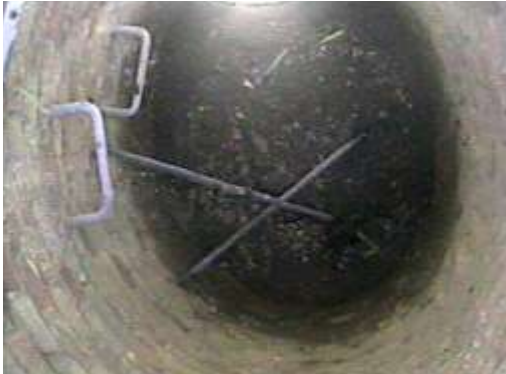
Defect 1

Condition: ☐ Sound ☐ Cracked ☐ Root Intrusion ☐ Deteriorated ☐ Leaks ☒ **Debris**

DEBRIS

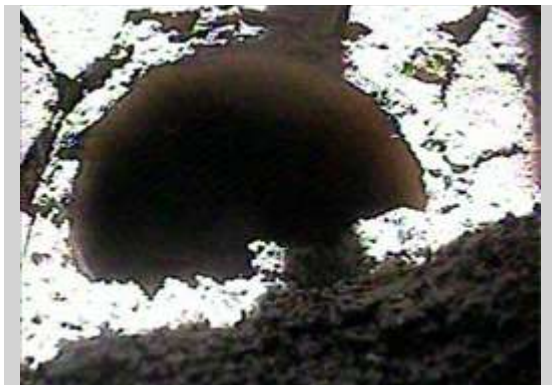
12 O'Clock Outflow

8 in. Circular Gravity Sewer
Pipe Out @ 12 O'Clock

Deposits: ☐ None ☐ Mud ☒ **Gravy** ☒ **Debris** ☐ Grease

Silt Depth: **4** (in.) Deposits Extent: **Medium**
